**BOARD OF ENQUIRY INTO MLPS DERAILMENT IN MODDERRIVIER**

**- HEUNINGSNESKLOOF, KIMBERLEY**

<b>OPERATOR</b>	<b>PASSENGER RAIL AGENCY OF SOUTH AFRICA (PRASA)</b>
<b>PERMIT NUMBER</b>	ASP0002NTS
<b>INVESTIGATION SUBJECT</b>	MODDERRIVIER-HEUNINGSNESKLOOF DERAILMENT
<b>DATE OF OCCURENCE</b>	18 AUGUST 2015
<b>REFERENCE NUMBER</b>	RSR/20150819/001

**THE REPORT OF A FORMAL BOARD OF INQUIRY WHICH INVESTIGATED  
THE DERAILMENT OF A SHOSHOLOZA MEYL LONG DISTANCE PASSEN-  
GER TRAIN, TRAIN 71010 ON 18 AUGUST 2015 BETWEEN MODDERRIVIER  
AND HEUNINGSLKOOF IN KIMBERLEY (NC)**

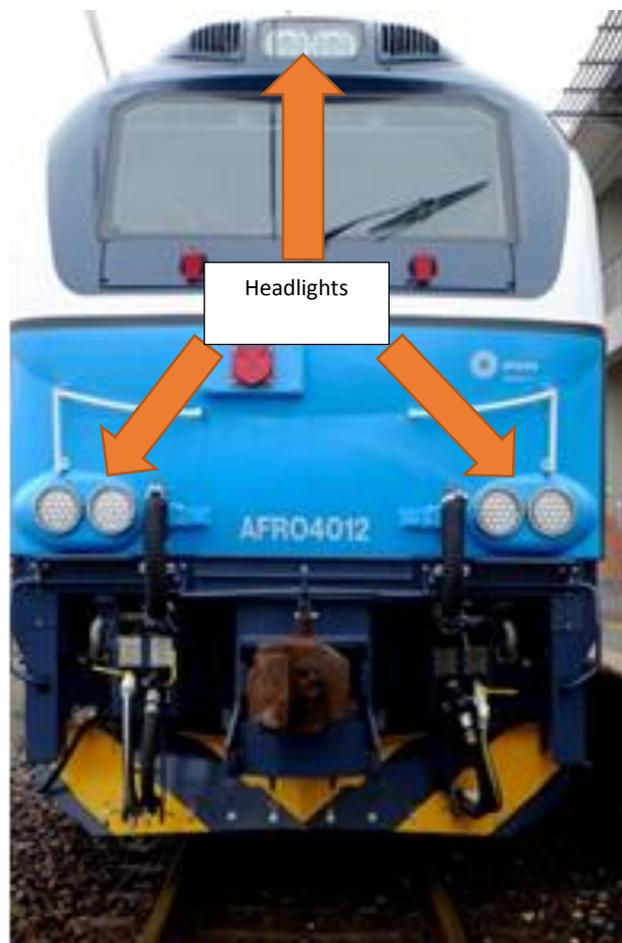
Figure 2: Headlights on Afro 4000 locomotive

- 7.1.6. both the assistant driver and the section manager confirmed that the illumination of the head light fitted on the Afro 4000 fleet of locomotives is bright enough to observe warning boards and any obstruction that could be on the track. The assistant also mentioned that the front wind screen of the locomotive also assist in the viewing the track due to its size (see Figure 2 below).

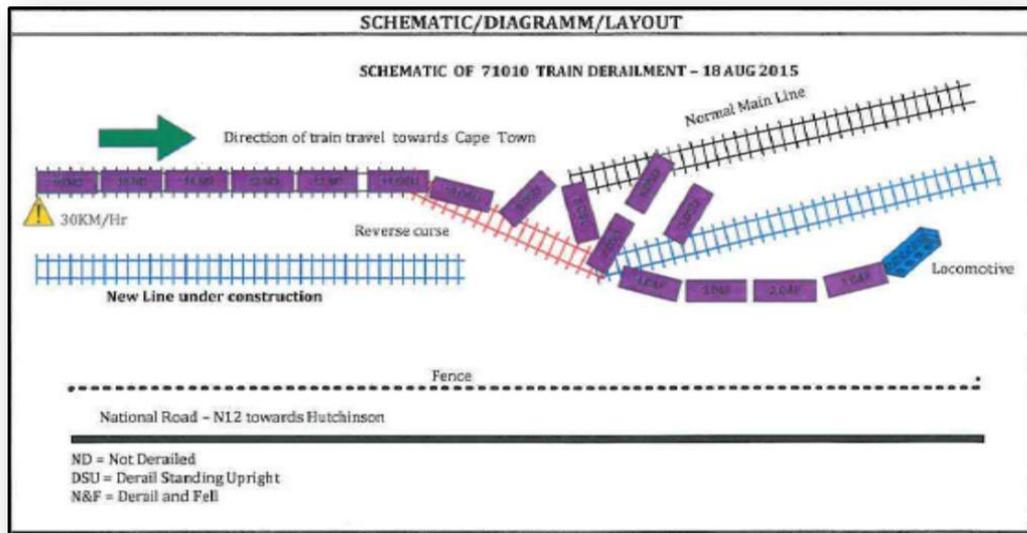
Figure 3 : Derailment site layout

- 7.2.1. The BOI established that the derailment occurred on a newly constructed temporary deviation/ slew that allowed for a transition between current mainline and the newly constructed line at kmp36/10-14 (see Figure 3 below).

- 7.2.2. We further established that the radius of the reverse curve was 400m at the time of the derailment and the condition of the rails; sleepers, ballast and formation were in good order. The newly cast thermit welds were properly joggled at the time of the incident to allow the train to traverse at a speed of 30km/h.

- 7.2.4. As stated above we can confirm that the condition of the permanent way and related infrastructure is deemed not to be the root cause of the incident.

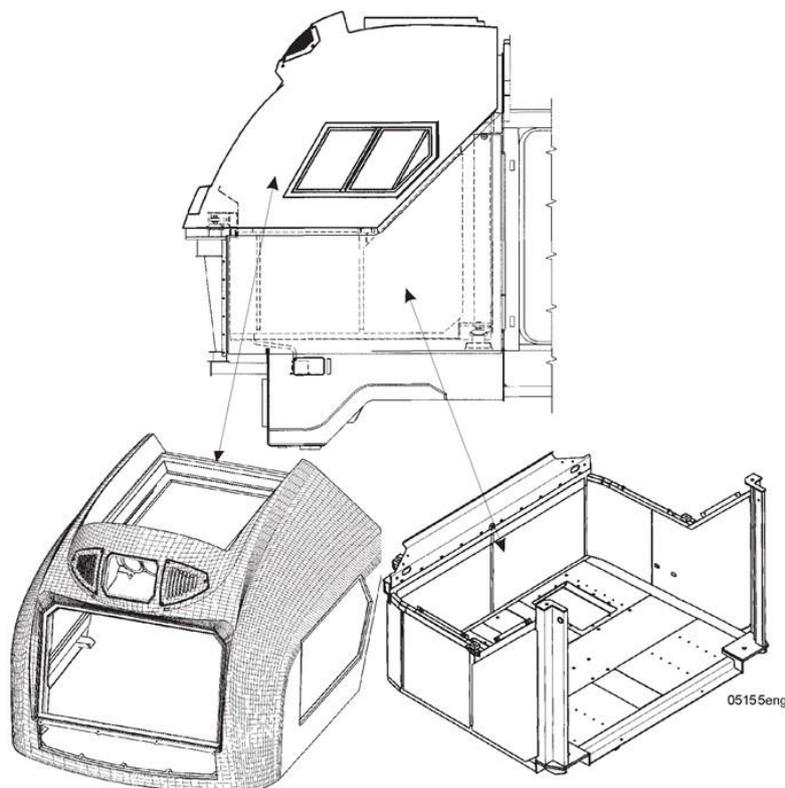
Figure 4: Afro 4000 cab structure

- 7.4.1. From the photographic and witnesses evidence, the incident occurred when the weather was clear and there was no problem with visibility;
- 7.4.2. When the train derailed, the assistant train driver, Mr. Boer testified that, he found himself under the locomotive roof a couple of meters from the locomotive. The sketch below shows the locomotive cab design where Polyester Fairing is used on the cab structure. This explains why the assistant driver was ejected out of the locomotive during the derailment and found himself under the rubble ahead of the locomotive.

1.8.3.4. PRASA must identify the risks and processes that will be used to mitigate the driver and the assistant being ejected from the locomotive during impact. In the event that the risk cannot be mitigated, PRASA must come up with a proposal on how the driver and the assistant will be protected in the cabin in case of an incident.
